Smith Home Inspection

Property Inspection Report

Property address: **238 roughs ave. Friant Ca 93627**

Inspection date: **Friday, October 19, 2018**

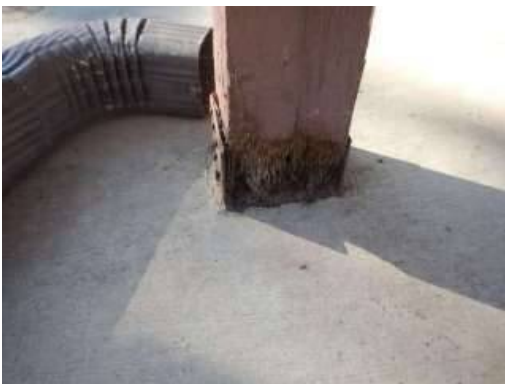
Fungal rot was found in support posts at one or more structures covering decks, patios and/or porches. Recommend that a qualified person repair as necessary. All rotten wood should be replaced.

Photo 1-1 Multiple posts have rot at the base.

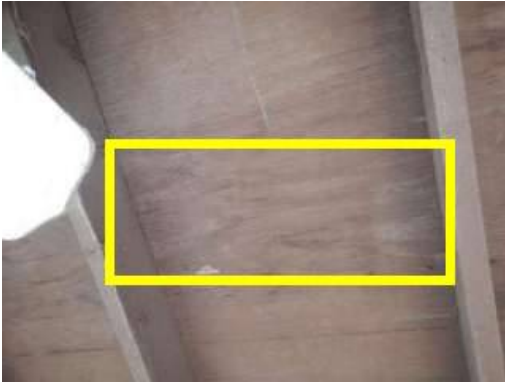
Photo 2-1

One or more deck, patio and/or porch covers were showed minor discoloration.. Recommend that a qualified person repair or replace as necessary, and per standard building practices.

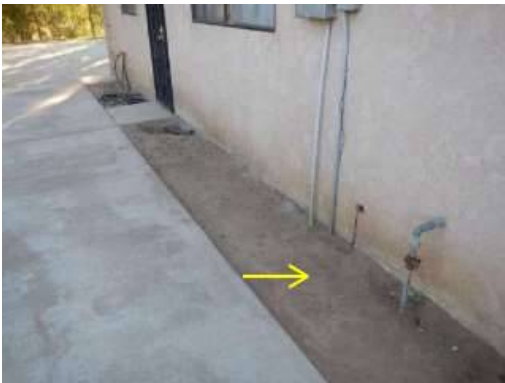
Photo 3-1 North side

The soil or grading sloped down towards building perimeters in one or more areas. This can result in water accumulating around building foundations or underneath buildings. At a minimum, monitor these areas, and areas under the structure in the future for accumulated water. If water does accumulate, recommend grading soil so it slopes down and away from buildings with a slope of at least 1 inch per horizontal foot for at least 6 feet out from buildings.

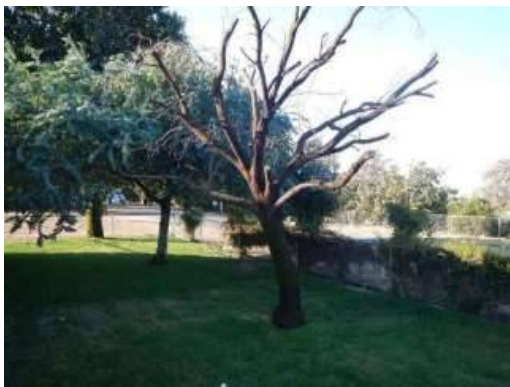
Photo 4-1 Front yard

The tree in the front yard is dead. Recommend removing before it falls. Safety hazard.

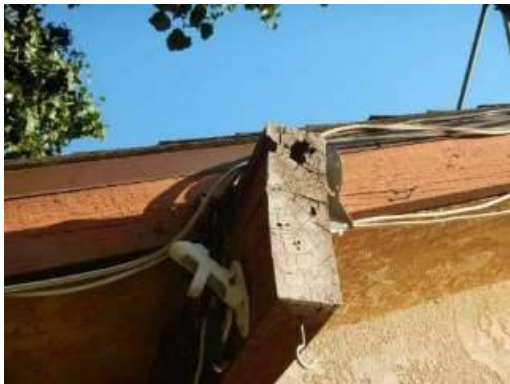
Photo 5-1 South side

Fungal rot was found at one or more fascia and/or exposed beams. Conducive conditions for rot should be corrected (e.g. wood-soil contact, reverse perimeter slope). Recommend that a qualified contractor repair as necessary. All rotten wood should be replaced.

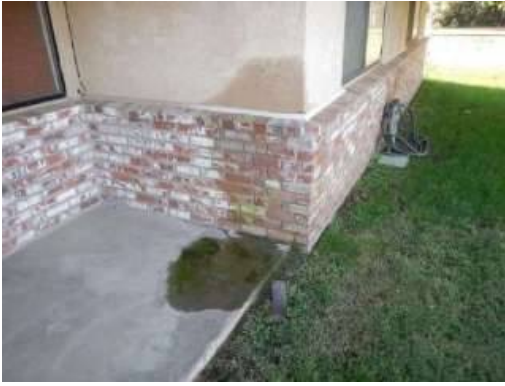
Photo 6-1 Front yard

It appears that the sprinklers are making contact with the exterior of the home. This could potentially cause damage to the exterior and the interior. Recommend adjustments.

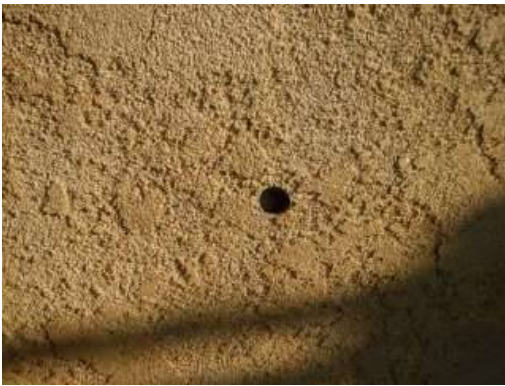
Photo 7-1 South side

One or more holes or gaps were found in siding or trim. Vermin, insects or water may enter the structure. Recommend that a qualified person repair as necessary.

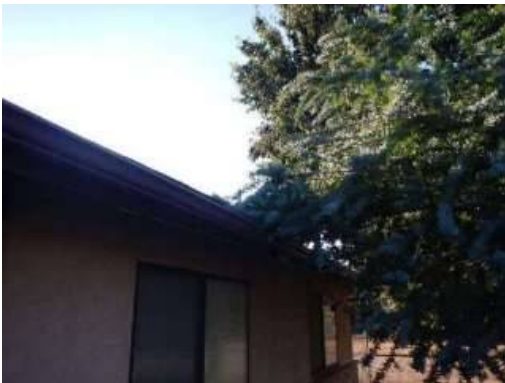
Photo 8-1 Front yard

Vegetation such as trees, shrubs and/or vines was in contact with or close to the building exterior. Vegetation can serve as a pathway for wood-destroying insects and can retain moisture against the exterior after it rains. This is a conducive condition for wood-destroying organisms. Recommend pruning, moving or removing vegetation as necessary to maintain at least 6 inches of space between it and the building exterior. A 1-foot clearance is better.

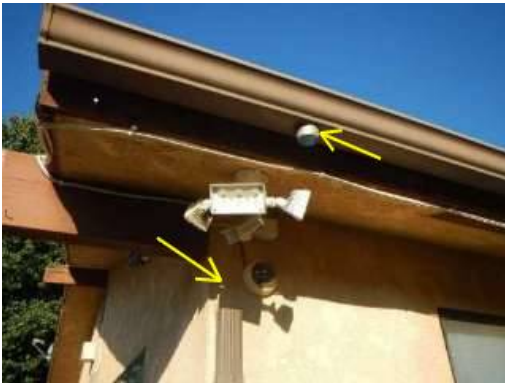
Photo 10-1 SE corner

One or more downspouts were incomplete and/or damaged. Rainwater can come in contact with the building exterior or accumulate around the building foundation as a result. This is a conducive condition for wood-destroying organisms. Recommend that a qualified person repair as necessary.

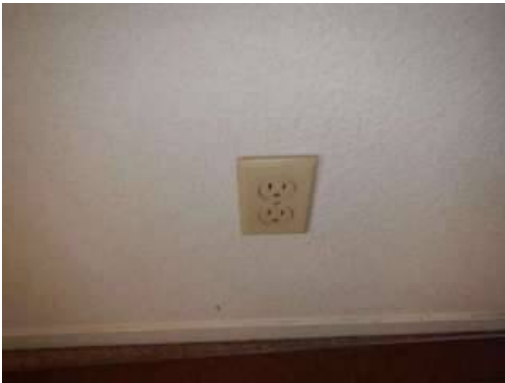
Photo 11-1 Livingroom

One or more electric receptacles and/or the boxes in which they were installed were loose and/or not securely anchored. Wire conductors can be damaged due to repeated movement and/or tension on wires, or insulation can be damaged. This is a shock and fire hazard. Recommend that a qualified electrician repair as necessary.

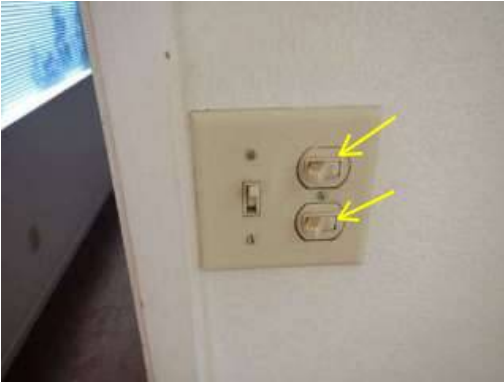
One or more wall switches were worn. The light or receptacle controlled by the switch was powered intermittently and/or if the switch was wiggled. These switches can overheat or arc and spark due to loose connections. This is a potential fire hazard. Recommend that a qualified electrician replace worn switches as necessary.

Photo 12-1 The double switch did not work properly.

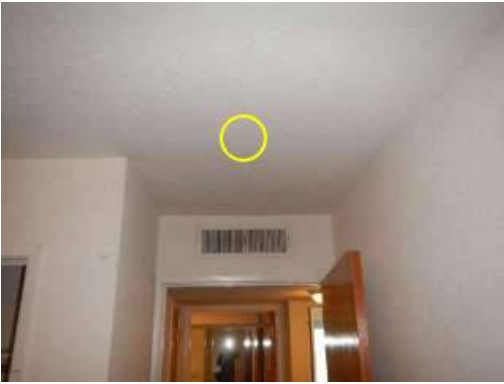
Photo 13-1 All bedrooms

Smoke alarms were missing from one or more bedrooms. Smoke alarms should be installed as necessary so a functioning alarm exists in each hallway leading to bedrooms, in each bedroom, on each level and in any attached garage. For more information, visit:

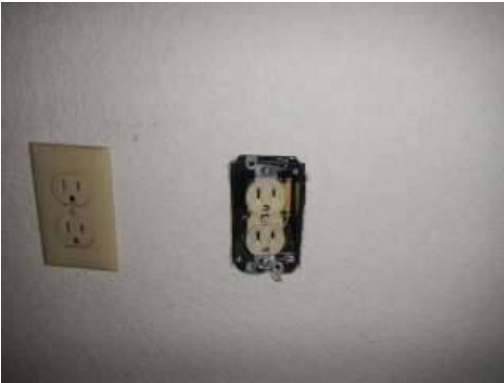
Photo 14-1 Garage

One or more cover plates for switches, receptacles or junction boxes were missing or broken. These plates are intended to contain fire and prevent electric shock from occurring due to exposed wires. Recommend that a qualified person install cover plates where necessary.

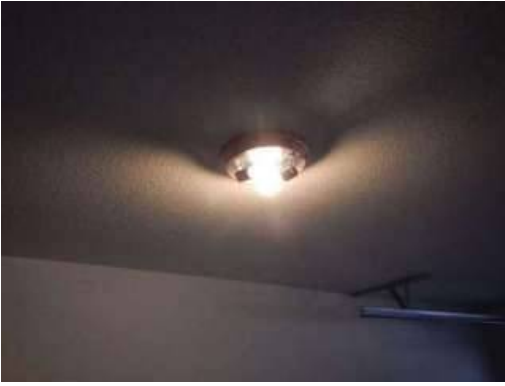
Photo 15-1 Garage

One or more globes or covers for light fixtures were missing or damaged. Recommend replacing as necessary to avoid exposed bulbs. With closet lighting or where flammable stored objects are near light fixtures, missing or broken covers can be a fire hazard.

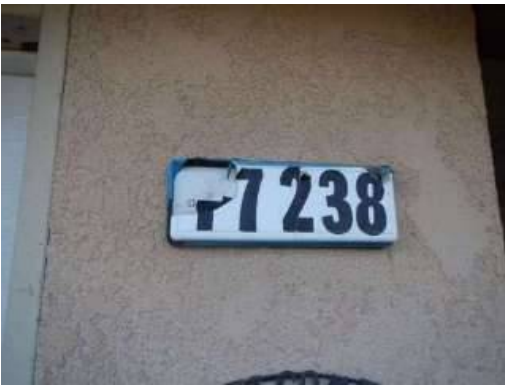
Photo 16-1

One or more light fixtures were damaged. Recommend that a qualified electrician repair or replace light fixtures as necessary.

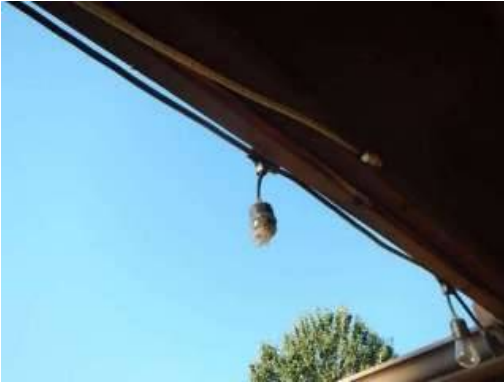
Photo 18-1 Patio lights

Bulbs in one or more light fixtures were missing or broken. These light fixtures couldn't be fully evaluated. If replacement bulbs are inoperable, then recommend that a qualified electrician evaluate and repair or replace light fixtures as necessary.

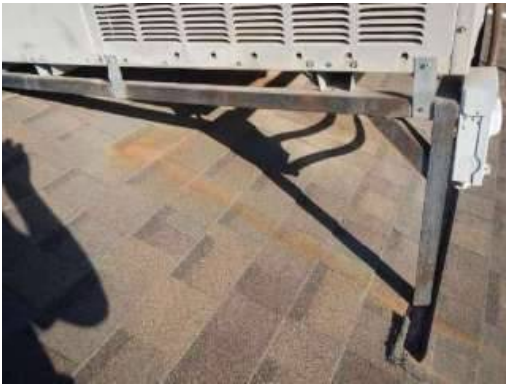
Photo 19-1

19) 🔍 The A/C unit had a rust stain on the underside of the unit. Cause is unknown. Recommend further investigation.

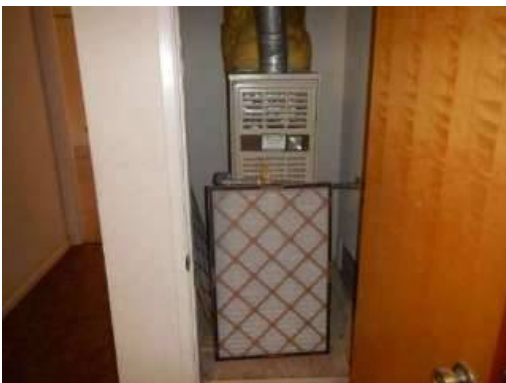
20) 📌 The furnace heating system was not fully evaluated because the gas supply was off. Recommend that a full evaluation be made by a qualified person when conditions have been corrected so the system is operable. Note that the inspector does not operate shut-off valves, pilot lights or circuit breakers, or any controls other than normal controls (thermostat).

Photo 20-1 Unable to test this furnace do to the face that the gas valve was turned off. Recommend further inspection

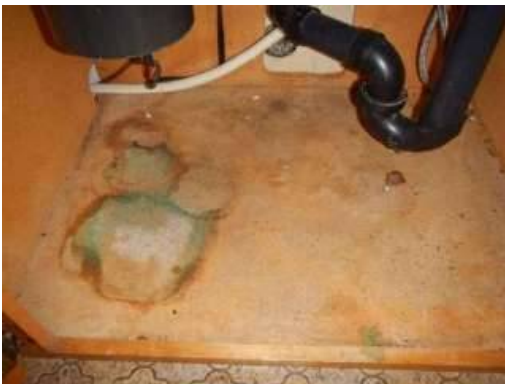
Photo 22-1

Water damage was found in shelving or cabinets below the sink. Recommend that a qualified contractor repair as necessary after any plumbing leaks have been repaired. If moisture is present then concealed areas should be dried thoroughly.

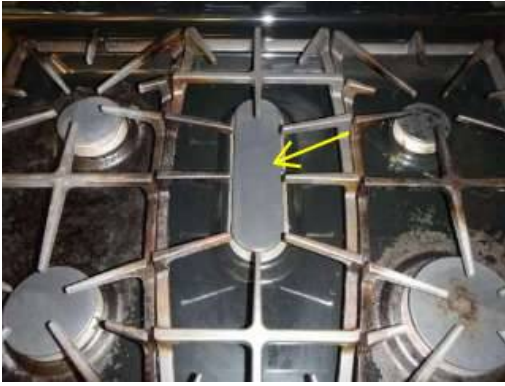
Photo 23-1

1 cooktop burner(s) were inoperable. Recommend that a qualified person repair as necessary.

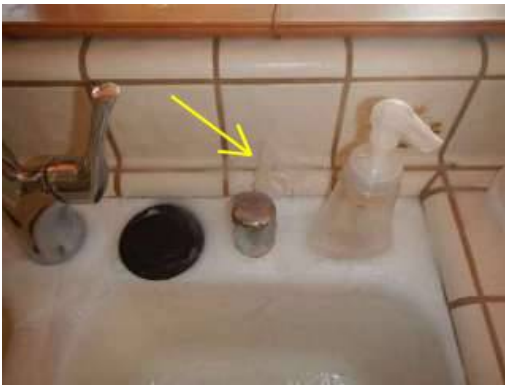
Photo 24-1

Water leaked from the dishwasher's air gap device when the dishwasher ran. Debris may be clogging the drain line or air gap device. Recommend that a qualified person clear debris or make repairs as necessary.

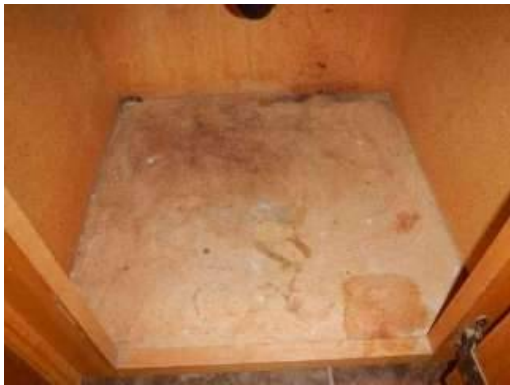
Photo 25-1 Hall bath

Water damage was found in shelving or cabinet components below one or more sinks at location(s) #A and B. Recommend that a qualified contractor repair as necessary after any plumbing leaks have been repaired. If moisture is present then concealed areas should be dried thoroughly.

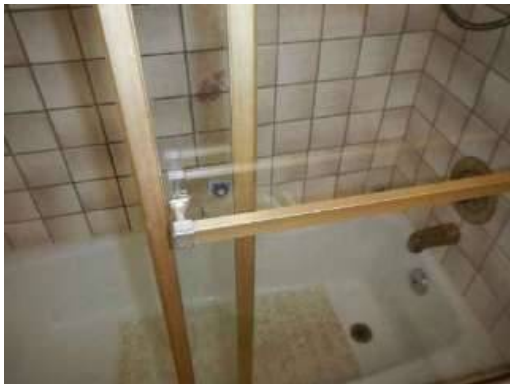
The shower enclosure at location(s) #A and B was deteriorated, damaged or substandard. Water can damage the wall structure as a result. Recommend that a qualified contractor repair or replace the surround as necessary.

Photo 26-1 Loose towel rack hall bath

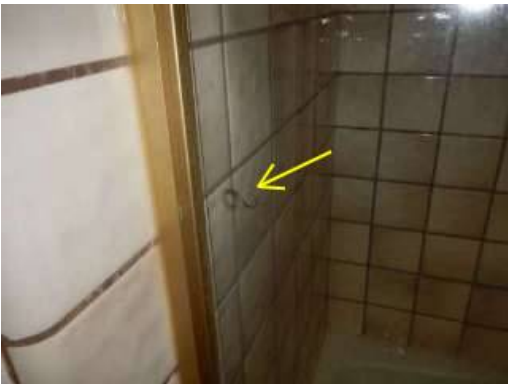
Photo 26-2 Missing handles to sliding doors.

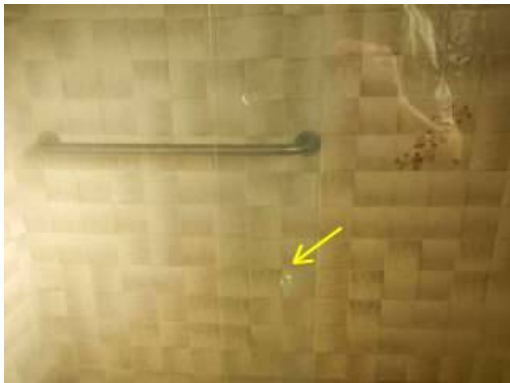
Photo 26-3 Missing handles to master shower doors.

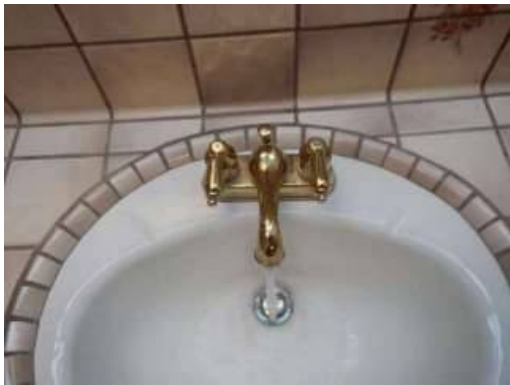
Photo 27-1 Hall bath stopper.

The master, and hall bath sink stopper was inoperable or missing. Recommend repair

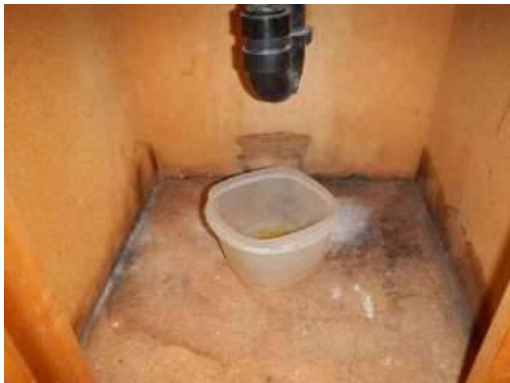
Photo 28-1 Master bath

28) One or more sink drains were leaking at location(s) #B. A qualified person should repair as necessary.

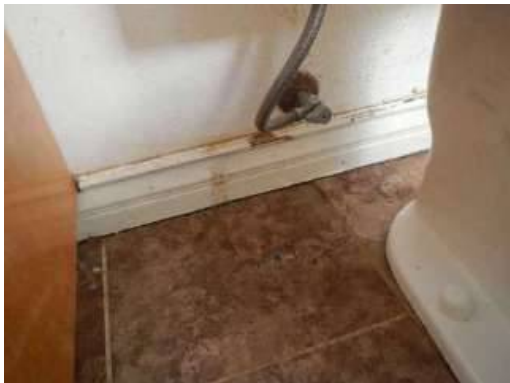
Photo 29-1 Master bath

29) The floor by the bathtub at location(s) #B was water-damaged. Recommend that a qualified person repair as necessary.

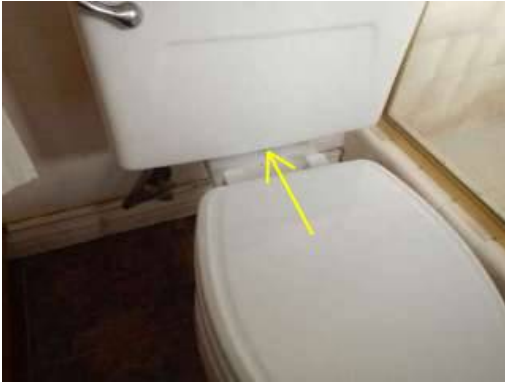
Photo 30-1 Master bath

30) The master bath toilet has a significant leak. Recommend repair.

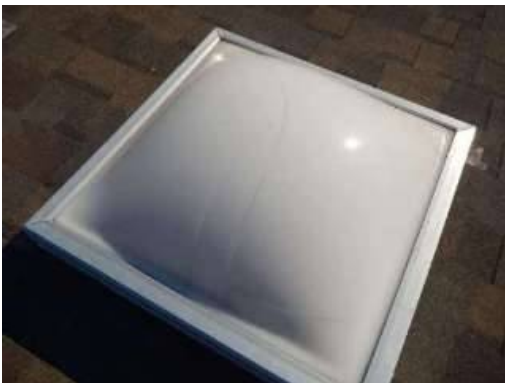
Photo 31-1 Skylight

The skylight plastic is cracked. This has 2 layers of plastic and didn't appear to be leaking.

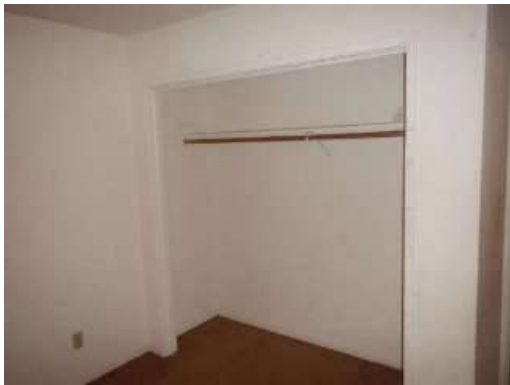
Photo 32-1 Bedroom

One or more interior doors were missing. Recommend that a qualified person replace or repair doors as necessary.

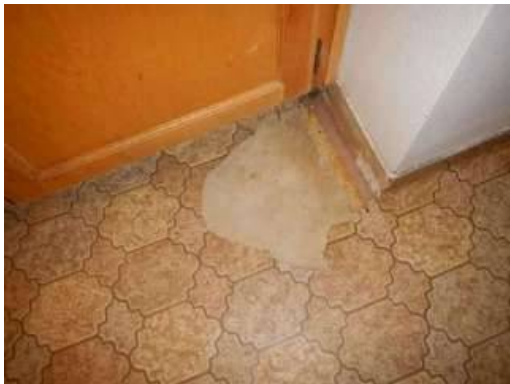
Photo 33-1 Laundry

Vinyl, linoleum or marmoleum flooring in one or more areas was damaged. If in a wet area, water can damage the sub-floor as a result. Recommend that a qualified contractor replace or repair flooring as necessary.

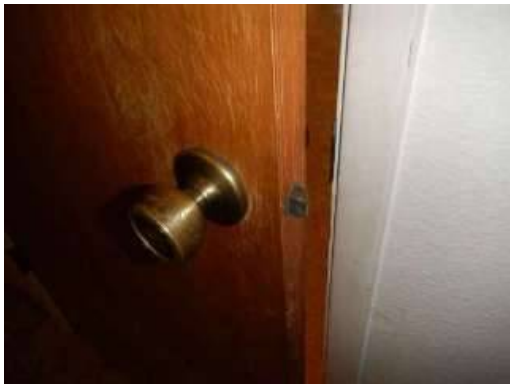
Photo 34-1 Laundry room door.

One or more interior doors wouldn't latch or were difficult to latch. Recommend that a qualified person repair as necessary. For example, by adjusting latch plates or locksets.

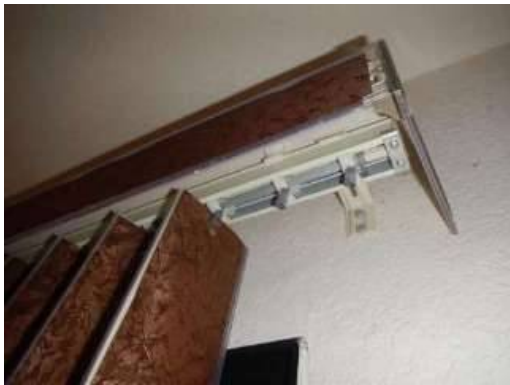
Photo X-1 Missing slats

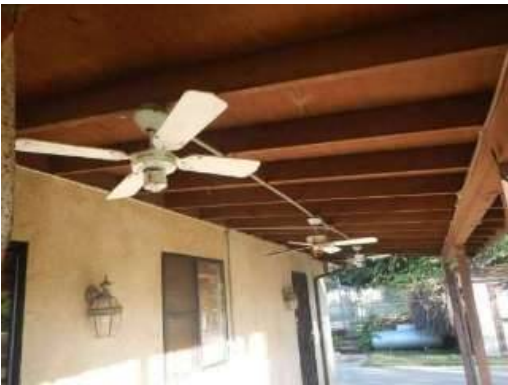
Photo X-2 Two out of three fans are inoperable on the back patio.
