Smith Home Inspection

Property Inspection Report

Property address: **238 roughs ave. Friant Ca 93627**

Inspection date: **Friday, October 19, 2018**

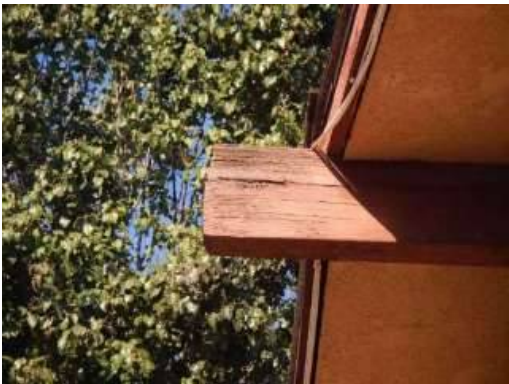
Photo 5-2 South side

Fungal rot was found at one or more fascia and/or exposed beams. Conducive conditions for rot should be corrected (e.g. wood-soil contact, reverse perimeter slope). Recommend that a qualified contractor repair as necessary. All rotten wood should be replaced.

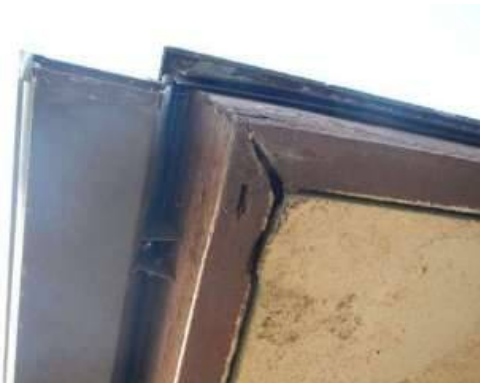
Photo 5-4 Multiple locations.

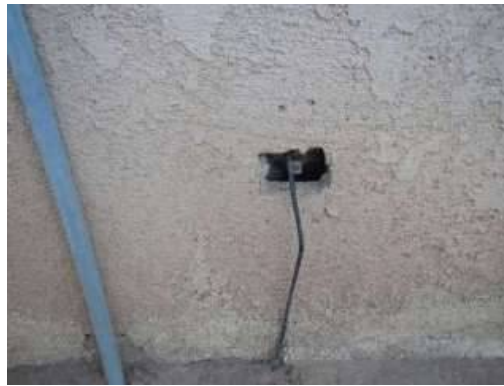
Photo 7-2 NW corner

One or more holes or gaps were found in siding or trim. Vermin, insects or water may enter the structure. Recommend that a qualified person repair as necessary.

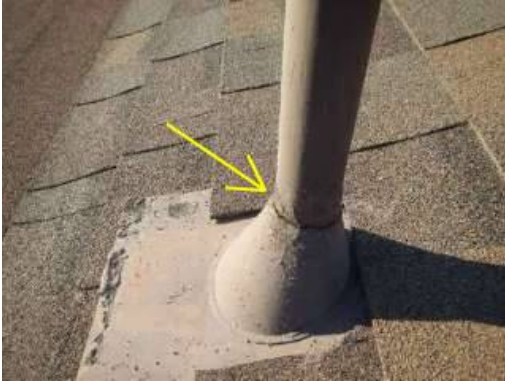
One or more roof flashings were substandard. Leaks can occur as a result. This is a conducive condition for wood-destroying organisms. Recommend that a qualified person repair as necessary.

Photo 9-1 Recommend installing new flashing tape around the plumbing vents to prevent moisture from entering the structure.

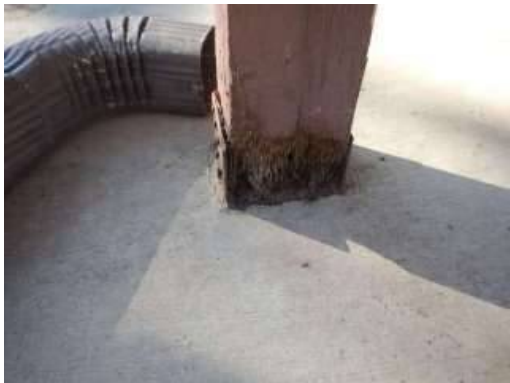
- 1) 🪛 Fungal rot was found in support posts at one or more structures covering decks, patios and/or porches. Recommend that a qualified person repair as necessary. All rotten wood should be replaced.

Photo 1-1 Multiple posts have rot at the base.

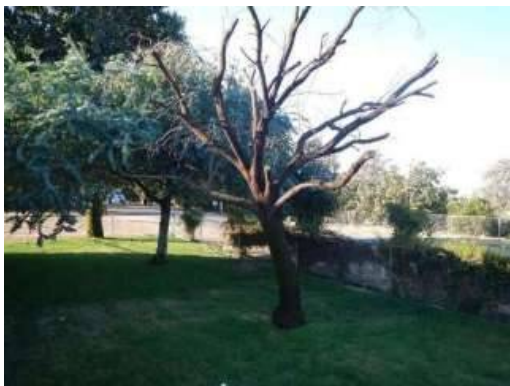
Photo 4-1 Front yard

- 4) 🪛 The tree in the front yard is dead. Recommend removing before it falls. Safety hazard.

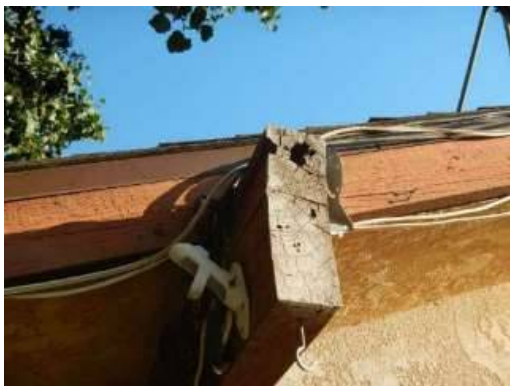
Photo 5-1 South side

- 5) 🪛 Fungal rot was found at one or more fascia and/or exposed beams. Conductive conditions for rot should be corrected (e.g. wood-soil contact, reverse perimeter slope). Recommend that a qualified contractor repair as necessary. All rotten wood should be replaced.

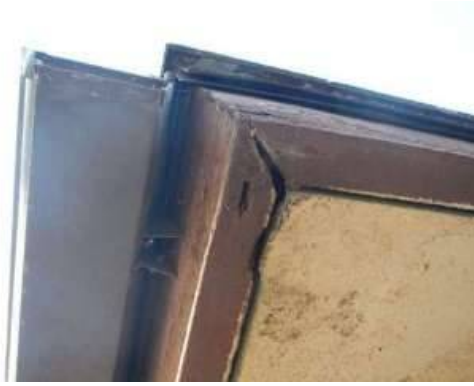
**Photo 5-4** Multiple locations.

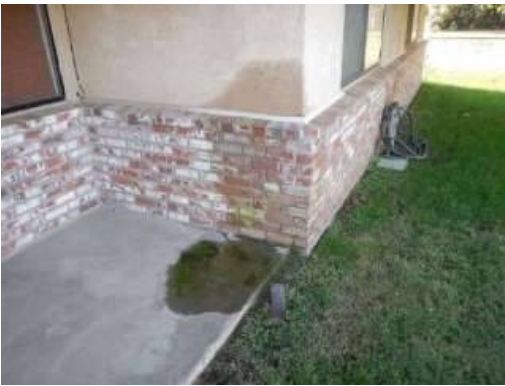
**Photo 6-1** Front yard

- 6) 🛠️ It appears that the sprinklers are making contact with the exterior of the home. This could potentially cause damage to the exterior and the interior. Recommend adjustments.

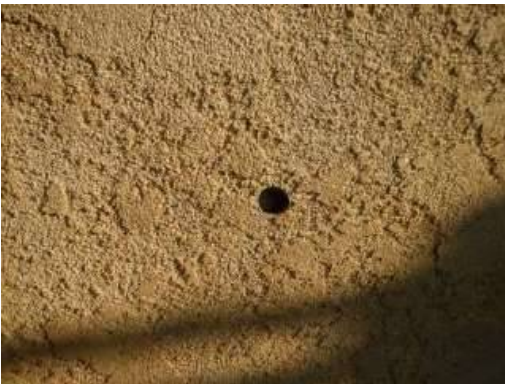
**Photo 7-1** South side

- 7) 🛠️ One or more holes or gaps were found in siding or trim. Vermin, insects or water may enter the structure. Recommend that a qualified person repair as necessary.

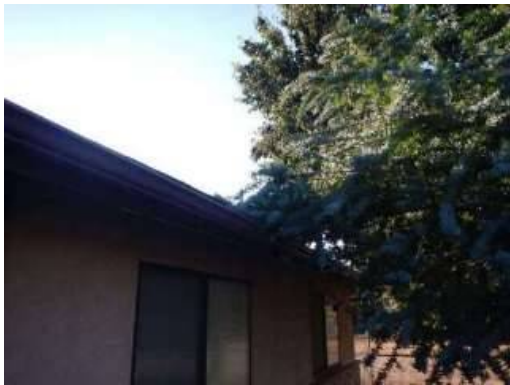
Photo 8-1 Front yard

- 8) 🌿 Vegetation such as trees, shrubs and/or vines was in contact with or close to the building exterior. Vegetation can serve as a pathway for wood-destroying insects and can retain moisture against the exterior after it rains. This is a conducive condition for wood-destroying organisms. Recommend pruning, moving or removing vegetation as necessary to maintain at least 6 inches of space between it and the building exterior. A 1-foot clearance is better.

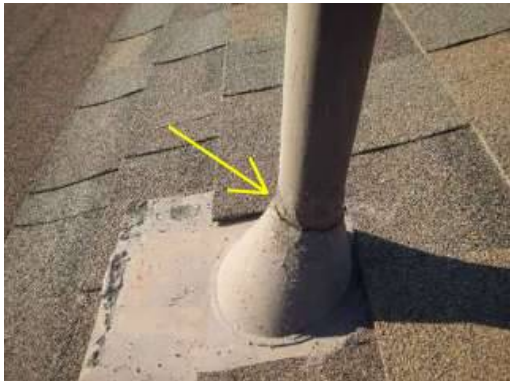
One or more roof flashings were substandard. Leaks can occur as a result. This is a conducive condition for wood-destroying organisms. Recommend that a qualified person repair as necessary.

Photo 9-1 Recommend installing new flashing tape around the plumbing vents to prevent moisture from entering the structure.

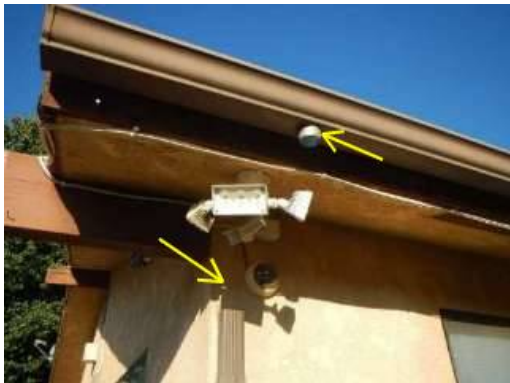
Photo 10-1 SE corner

One or more downspouts were incomplete and/or damaged. Rainwater can come in contact with the building exterior or accumulate around the building foundation as a result. This is a conducive condition for wood-destroying organisms. Recommend that a qualified person repair as necessary.

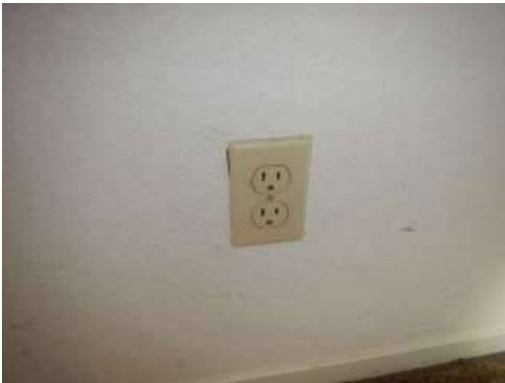
Photo 11-3 Master bedroom

One or more electric receptacles and/or the boxes in which they were installed were loose and/or not securely anchored. Wire conductors can be damaged due to repeated movement and/or tension on wires, or insulation can be damaged. This is a shock and fire hazard. Recommend that a qualified electrician repair as necessary.

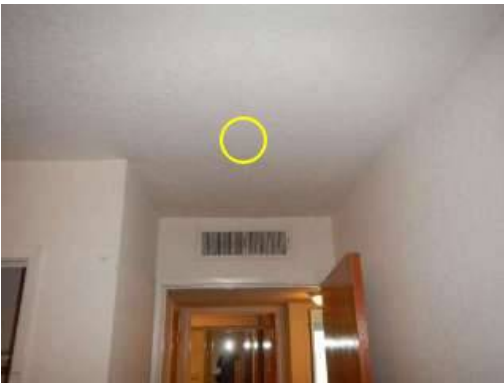
Photo 13-1 All bedrooms

Smoke alarms were missing from one or more bedrooms. Smoke alarms should be installed as necessary so a functioning alarm exists in each hallway leading to bedrooms, in each bedroom, on each level and in any attached garage. For more information, visit:

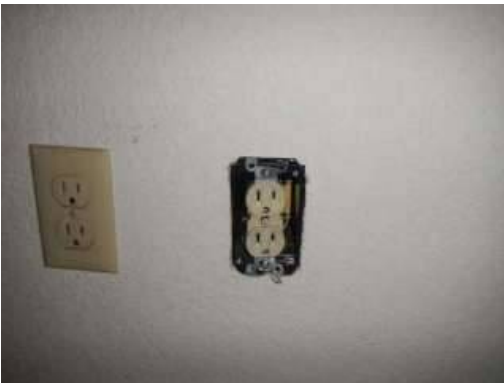
Photo 14-1 Garage

One or more cover plates for switches, receptacles or junction boxes were missing or broken. These plates are intended to contain fire and prevent electric shock from occurring due to exposed wires. Recommend that a qualified person install cover plates where necessary.

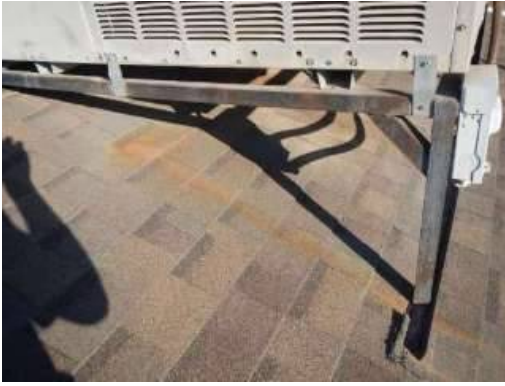
Photo 19-1

- 19) The A/C unit had a rust stain on the underside of the unit. Cause is unknown. Recommend further investigation.

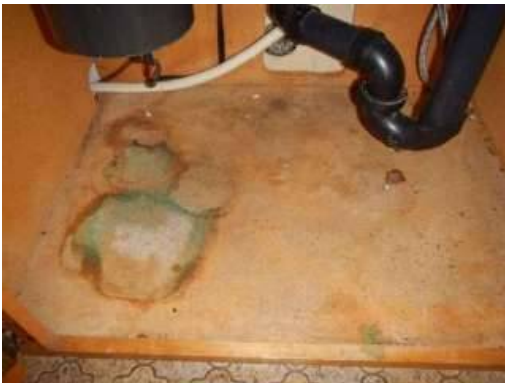
Photo 22-1

22) 🔧 Water damage was found in shelving or cabinets below the sink. Recommend that a qualified contractor repair as necessary after any plumbing leaks have been repaired. If moisture is present then concealed areas should be dried thoroughly.

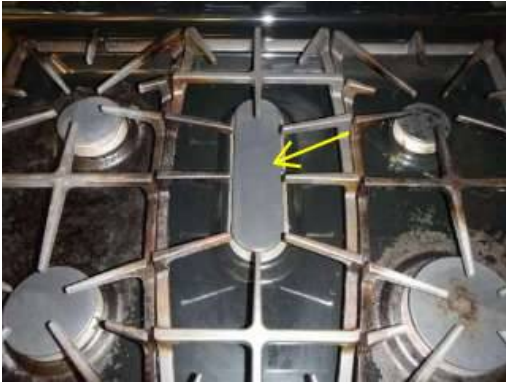
Photo 23-1

23) 🔧 1 cooktop burner(s) were inoperable. Recommend that a qualified person repair as necessary.

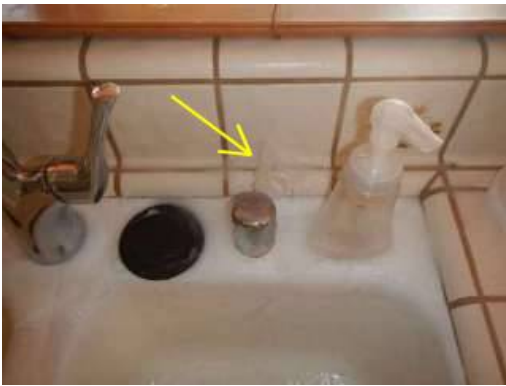
Photo 24-1

Water leaked from the dishwasher's air gap device when the dishwasher ran. Debris may be clogging the drain line or air gap device. Recommend that a qualified person clear debris or make repairs as necessary.

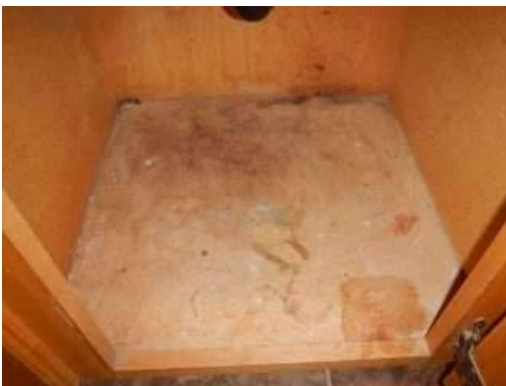
Photo 25-1 Hall bath

Water damage was found in shelving or cabinet components below one or more sinks at location(s) #A and B. Recommend that a qualified contractor repair as necessary after any plumbing leaks have been repaired. If moisture is present then concealed areas should be dried thoroughly.

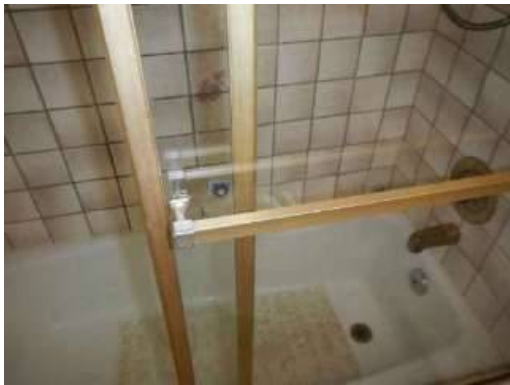
The shower enclosure at location(s) #A and B was deteriorated, damaged or substandard. Water can damage the wall structure as a result. Recommend that a qualified contractor repair or replace the surround as necessary.

Photo 26-1 Loose towel rack hall bath

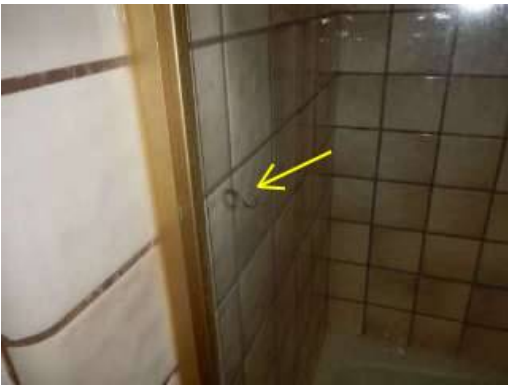
Photo 26-2 Missing handles to sliding doors.

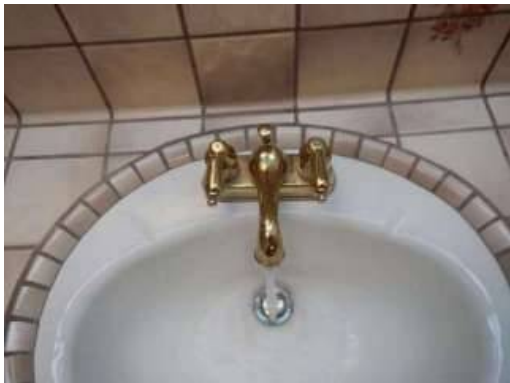
27) 🛠️🔧 The master, and hall bath sink stopper was inoperable or missing. Recommend repair

Photo 27-1 Hall bath stopper.

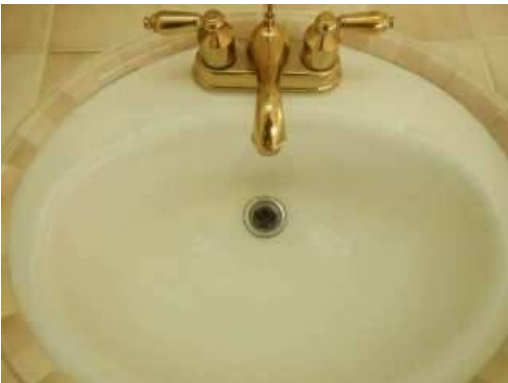
Photo 27-2 Master bath stopper

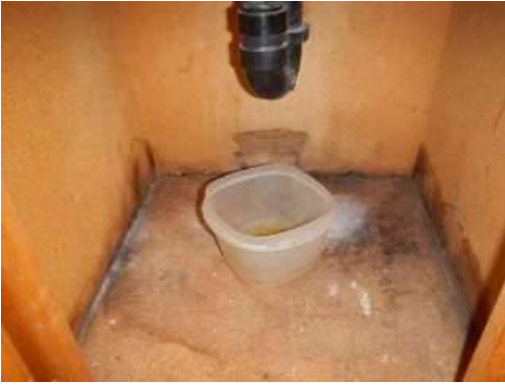
Photo 28-1 Master bath

28) 🛠️🔧 One or more sink drains were leaking at location(s) #B. A qualified person should repair as necessary.

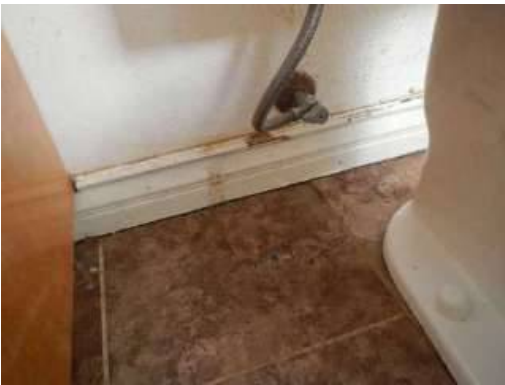
Photo 29-1 Master bath

The floor by the bathtub at location(s) #B was water-damaged. Recommend that a qualified person repair as necessary.

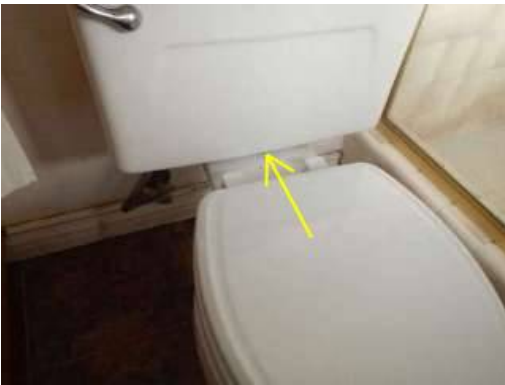
Photo 30-1 Master bath

The master bath toilet has a significant leak. Recommend repair.

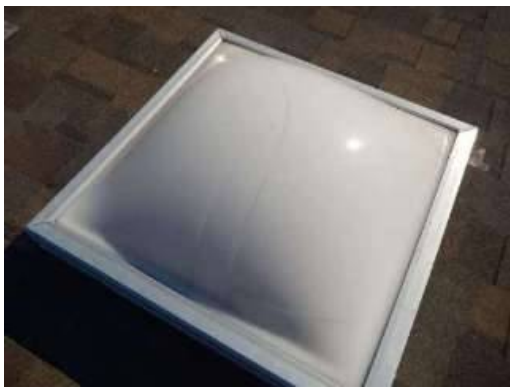
Photo 31-1 Skylight

The skylight plastic is cracked. This has 2 layers of plastic and didn't appear to be leaking.

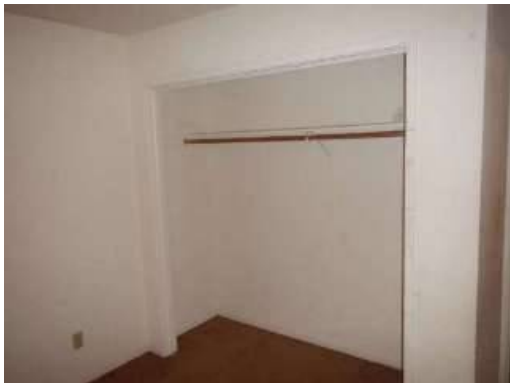
Photo 32-1 Bedroom

One or more interior doors were missing. Recommend that a qualified person replace or repair doors as necessary.

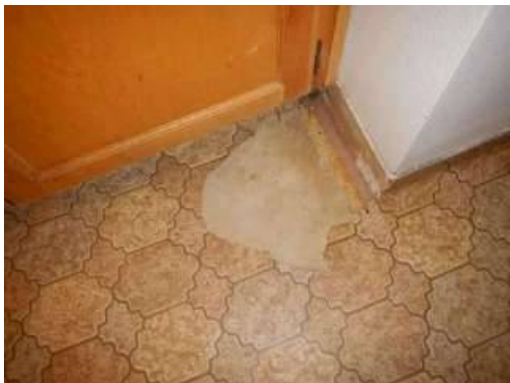
Photo 33-1 Laundry

Vinyl, linoleum or marmoleum flooring in one or more areas was damaged. If in a wet area, water can damage the sub-floor as a result. Recommend that a qualified contractor replace or repair flooring as necessary.

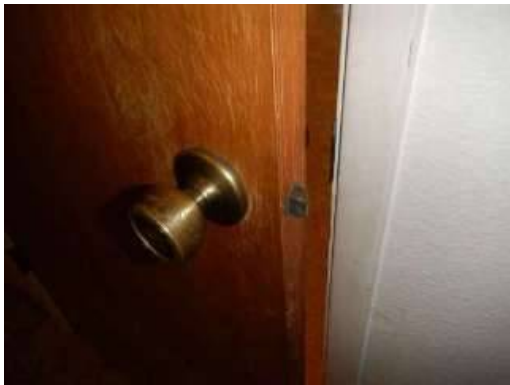
One or more interior doors wouldn't latch or were difficult to latch. Recommend that a qualified person repair as necessary. For example, by adjusting latch plates or locksets.

Photo 34-1 Laundry room door.
